Ett Marine Testing Laboratories

Second Plate All Marine Test Report May 4 2009

This report covers the testing in a marine environment of the second set of Plate All samples using different formulations and coating thicknesses. Samples were prepared on both wood substrate, and sheet plexiglass substrate. These samples were marked with brass tags for identification.

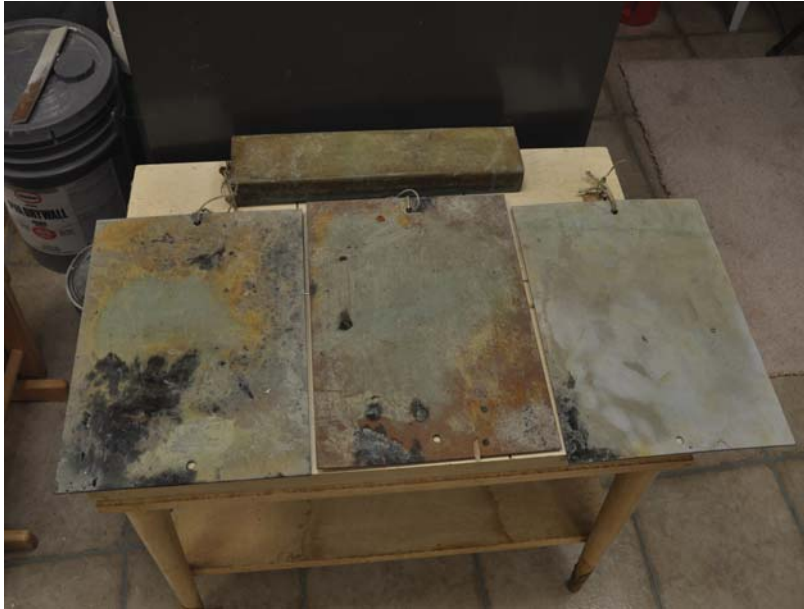
All Samples Coated Sides

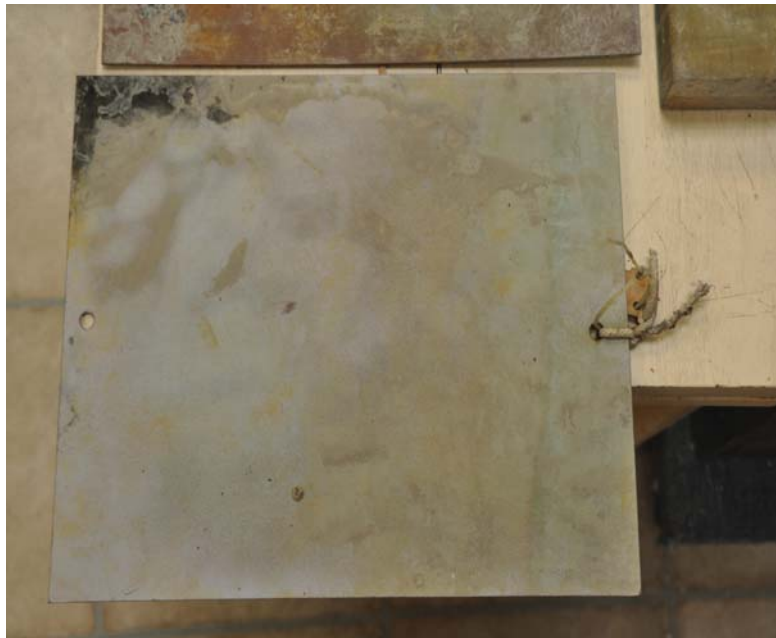
Sample 6 Coated Side

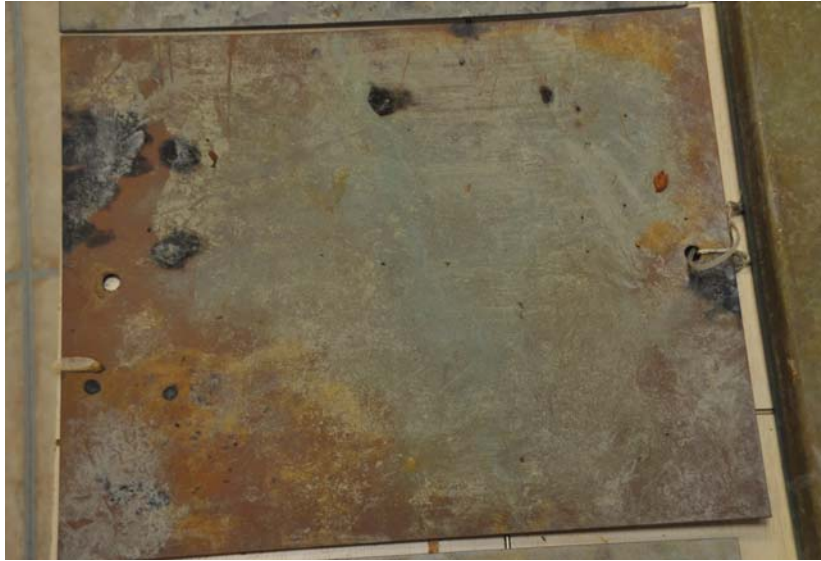
Sample 5 Coated Side

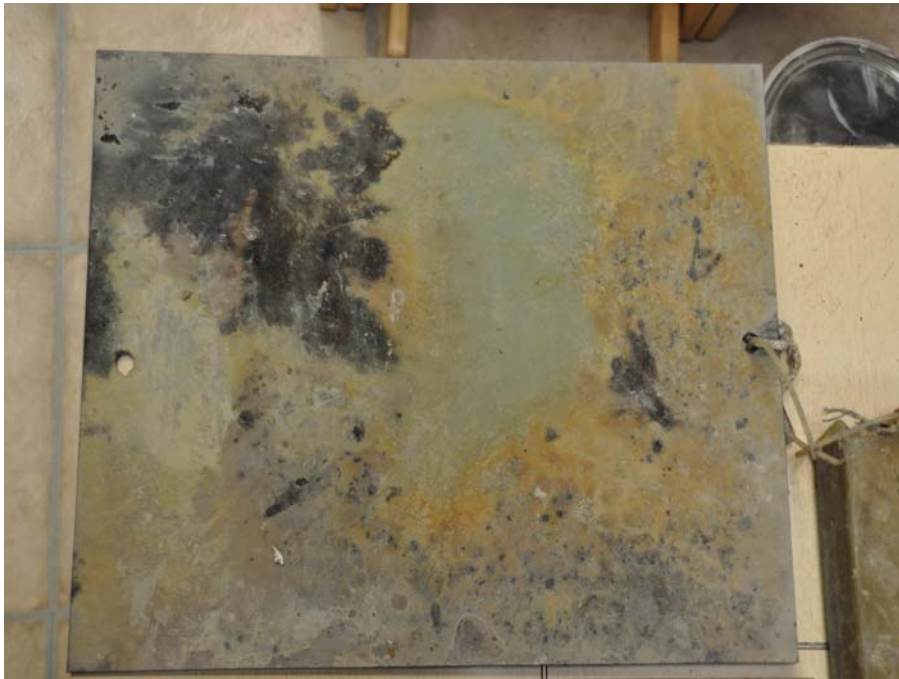
Sample 8 Coated side

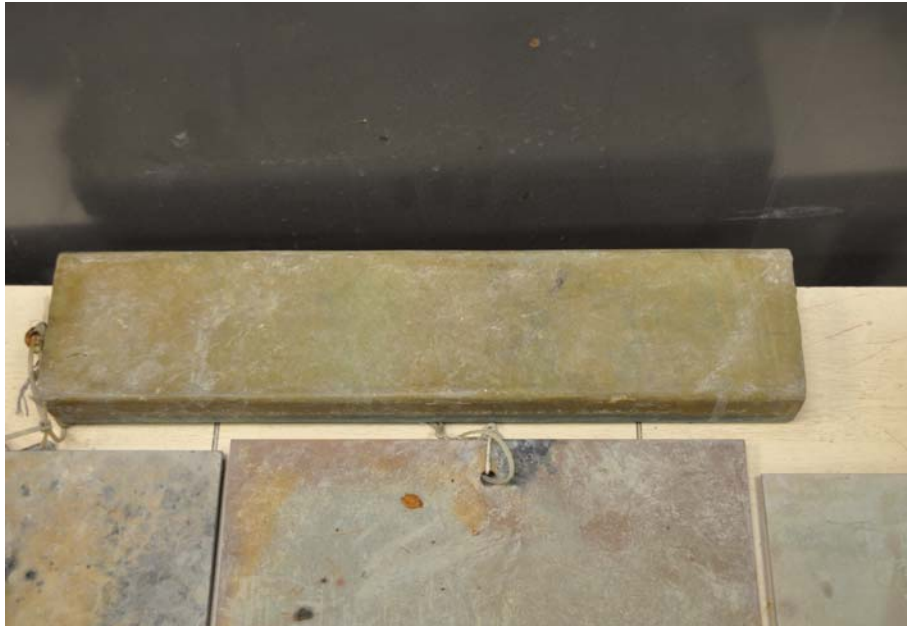
Several wood samples were lost during the testing. One sample consisting of a pressure treated 2x4 segment coated with a waterproof epoxy compound called Gluvit, and subsequently coated on one surface with a plate All formulation containing finely divided Copper powder. This sample was found to be unaffected by marine growth .

sample 4 Uncoated Side (Epoxy)

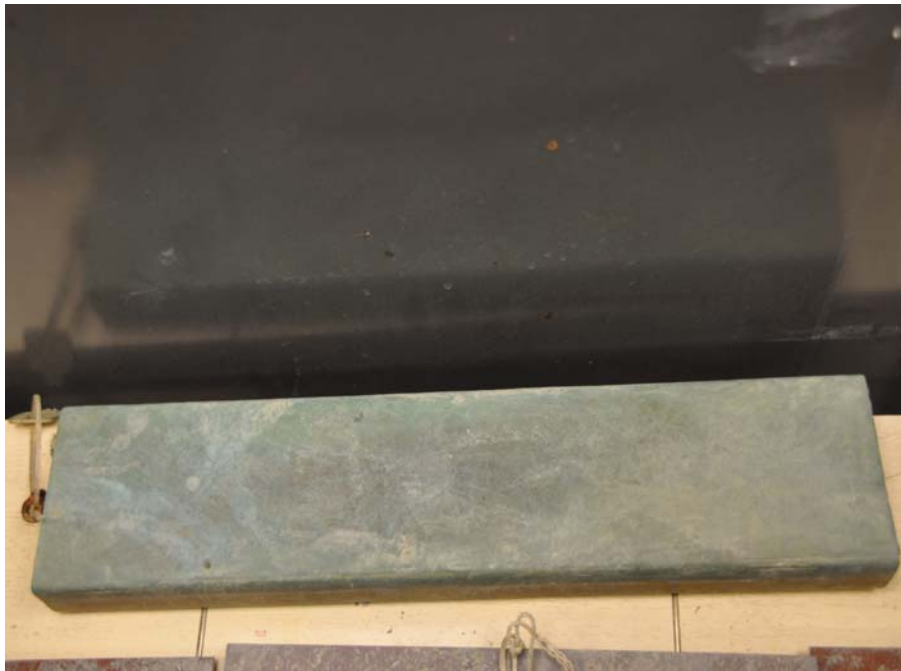
Sample 4 Coated Side

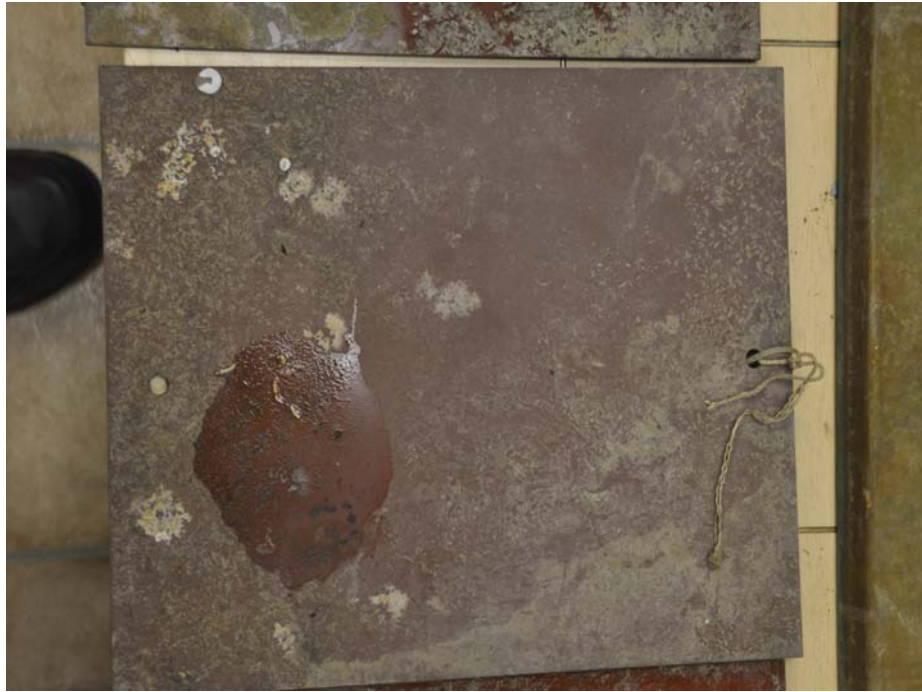
Sample 5 Coated Side

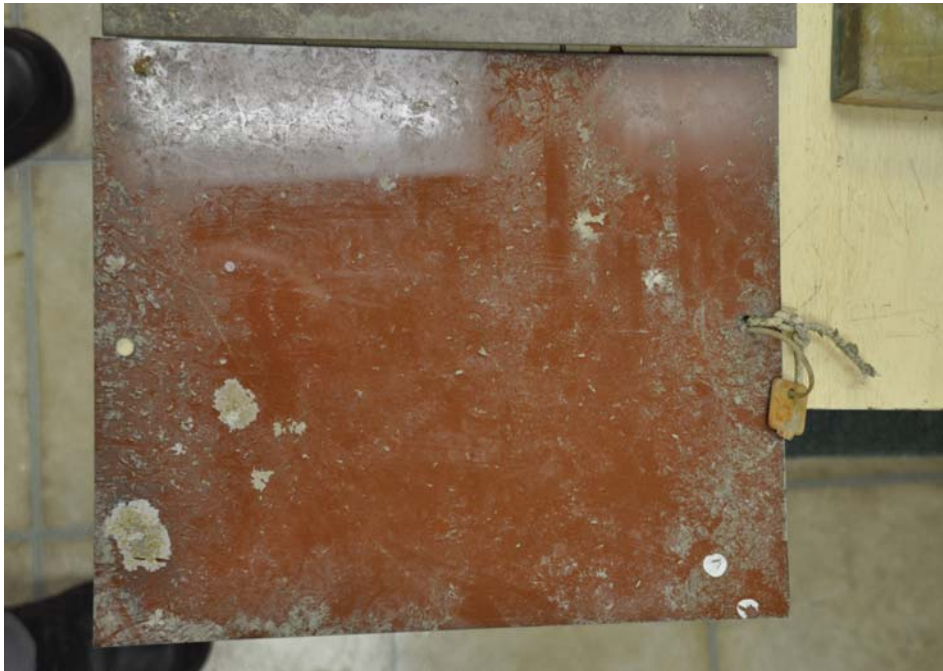
Three samples were recovered which consisted of plexiglass sheets coated with Plate All Formulations. One of these samples were coated on both sides and the third was coated on both sides. Adherence of marine growth was minimal in all samples. The uncoated sides of the plexiglass sheet had some marine growth but the amount was much less than expected. This may be due to the copper in the Plate All coating leaching into the water and providing some protection to the uncoated side.

Sample 6 Uncoated Side

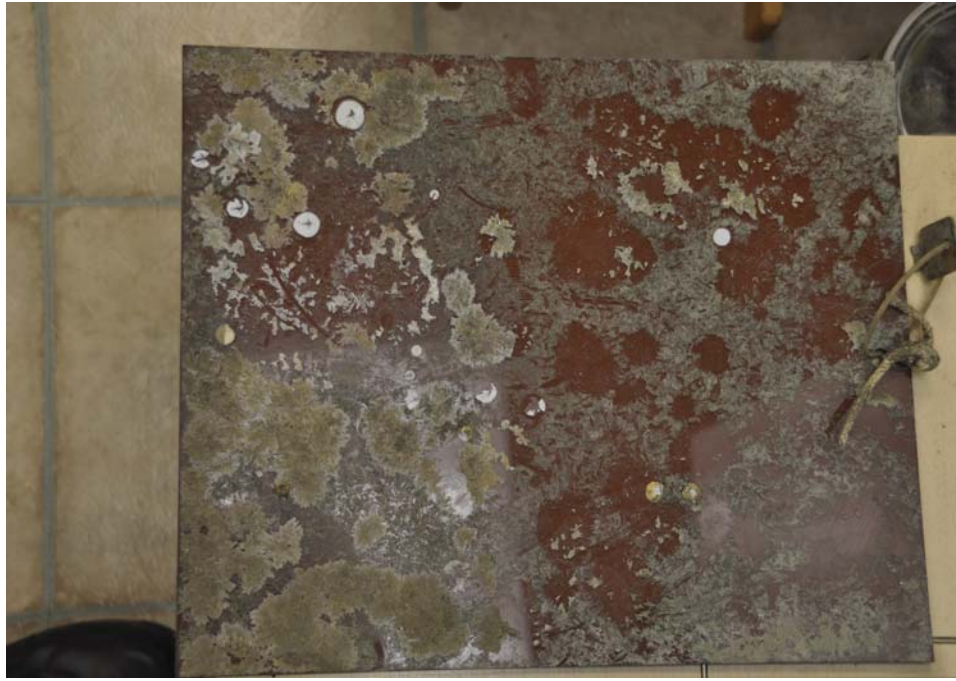
Sample 8 Uncoated Side
